# Test Report

Number	18-002246-PR01 (PB-A01-02-en-02)
Owner (Client)	Salamander Industrie-Produkte GmbH Jakob-Sigle-Str. 58 86842 Türkheim Germany
Product	<b>Fixed light with mullion</b>
Designation	Shipping name: <b>Streamline 60</b>
Details	Manufacturer Salamander, Industrie-Produkte GmbH - Türkheim; Material Polyvinyl Chloride unplasticized (PVC-U) white; Type of opening Fixed; Overall dimensions (W x H) 1400 mm x 1500 mm
Special features	test sequence
Order	Testing of air permeability, watertightness, resistance to wind load
Contents	The test report contains a total of 16 pages and annexe (7 pages).
Note	Replaces Test Report: no. 18-002246-PR01 PB-A01-02-en-01 dated 23.08.2018. The test report shall only be published in its unabbreviated form. The “Guidance Sheet for the Use of ift Test Documents” applies.

Testing of air permeability, watertightness, resistance to wind load

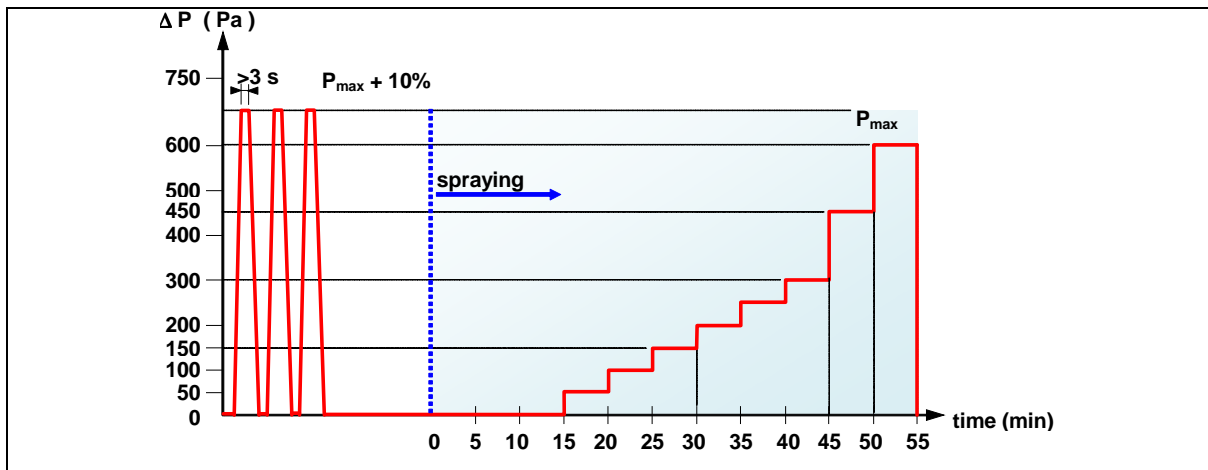
Prior to the test, three positive pressure pulses were applied to the test specimen. Subsequently, the external surface of the test specimen was constantly sprayed with water through nozzles, conforming to the standard. After a 15-minute pressureless spraying period an additional overpressure in terms of subsequent pressure steps was applied. The pressure steps were defined by the standard and were kept for 5 minutes each (see illustration). Watertightness was tested up to the maximum test pressure difference.

**Illustration** Test sequence for watertightness

The water volume applied and the angle of spray depend on the intended type of installation of the component (protected / unprotected) and the height of the component (< / > 2.5 m) according to the standard. The required water volume and the angle of spray are documented in the measuring data sheet.

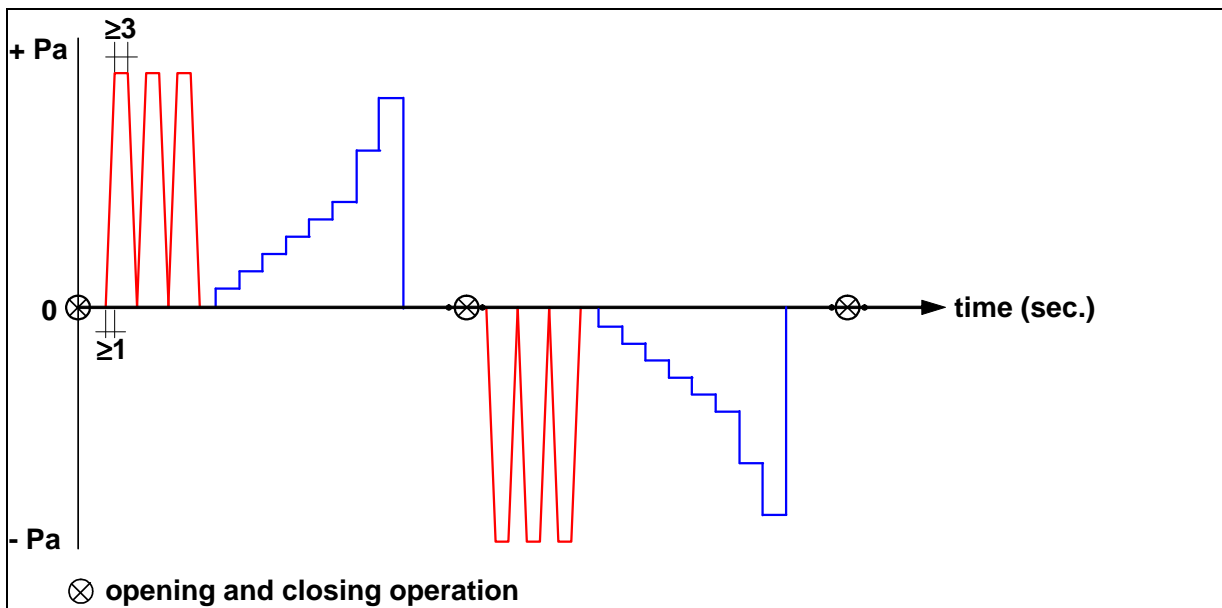
Air permeability was tested for the respective pressure steps at negative pressure and positive pressure in accordance with the following diagram. At the beginning of each measurement the test specimen was exposed to three pressure pulses.

Illustration Test sequence for air permeability

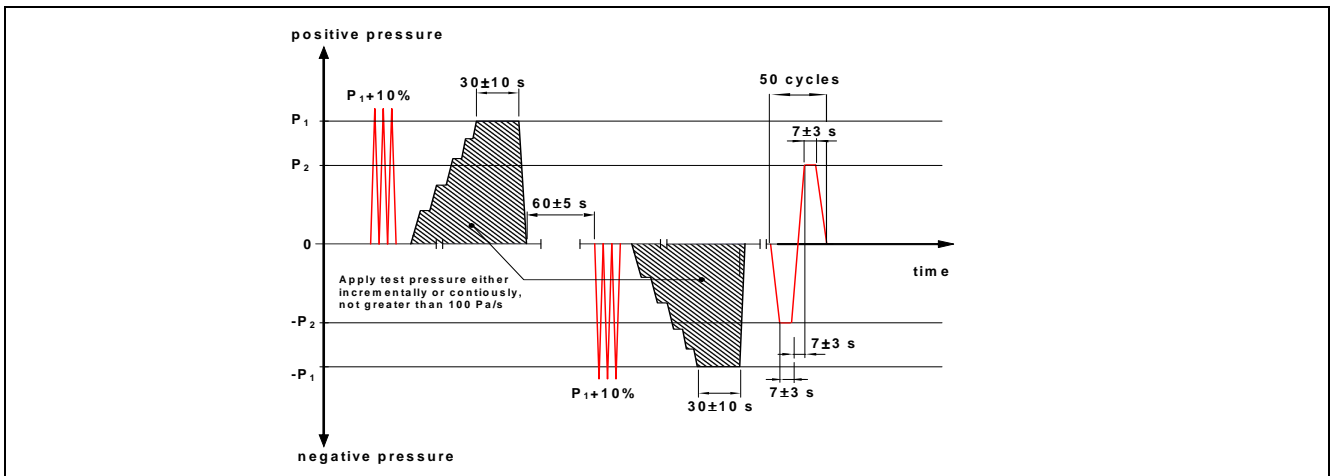
Resistance to wind load was tested in accordance with the standard and conducted in steps at positive pressure and negative pressure up to the test pressure p1. The test specimen was exposed to three pressure pulses  $\Delta p1 + 10\%$ . This was followed by determination of the frontal deflection of test specimen for each pressure step when exposed to positive test pressure  $\Delta p1$  and negative test pressure  $-\Delta p1$ . Then the test specimen was subjected to 50 cycles including alternating positive and negative pressures of  $\pm \Delta p2 = \Delta p1 - 50\%$ .

**Illustration** Test sequence for resistance to wind load - Deflection and alternating positive/negative pressures

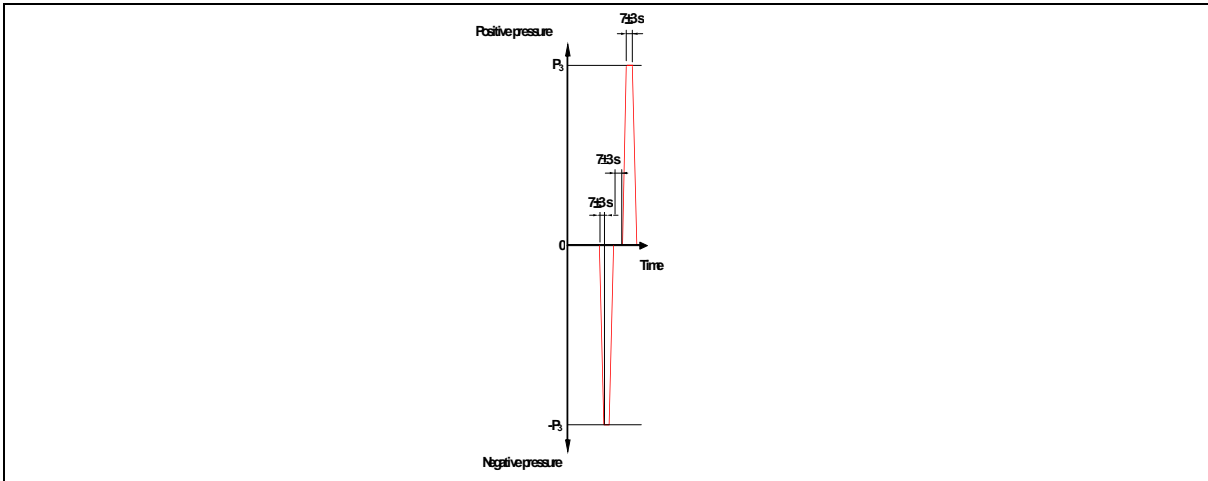
The wind resistance test (safety test) was conducted at negative pressure and positive pressure in accordance with EN 12211 up to test pressure  $\Delta p_3 = \Delta p_1 + 50\%$ .

**Illustration** Test sequence for resistance to wind load - safety test

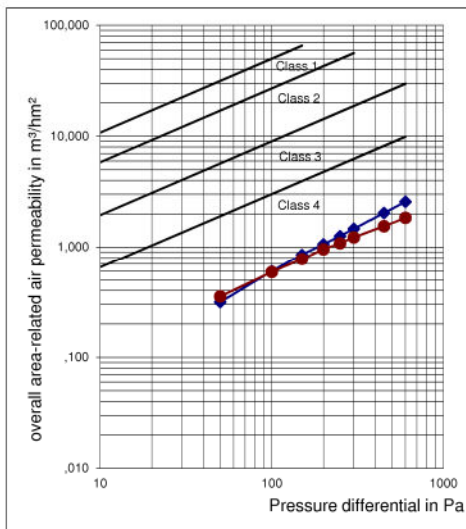
**Diagram:** Overall area-related air permeability (positive and negative wind pressures)

Pressure differential Pa	50	100	150	200	250	300	450	600
	Flow rate (volume) m³/h	0,7	1,3	1,8	2,2	2,6	3,1	4,3	5,4
	Overall area-related m³/hm²	0,31	0,60	0,85	1,06	1,26	1,46	2,03	2,56

Pressure differential Pa	50	100	150	200	250	300	450	600
	Flow rate (volume) m³/h	0,7	1,2	1,6	2,0	2,3	2,6	3,2	3,9
	Overall area-related m³/hm²	0,35	0,59	0,78	0,95	1,09	1,22	1,55	1,84

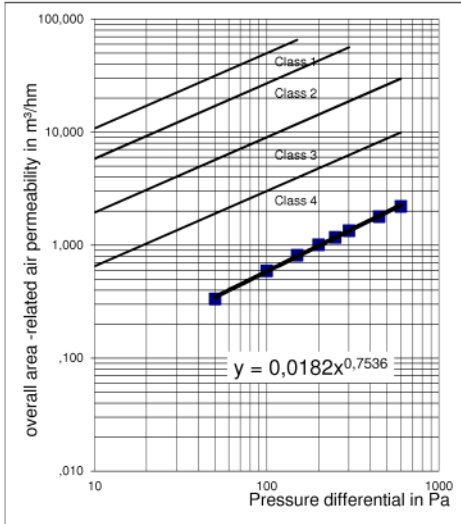
**Diagram:** Overall area-related air permeability (average value from positive and negative wind pressures)

Pressure differential Pa	50	100	150	200	250	300	450	600
	Flow rate (volume) m³/h	0,7	1,2	1,7	2,1	2,5	2,8	3,8	4,6
	Overall area-related m³/hm²	0,3	0,6	0,8	1,0	1,2	1,3	1,8	2,2

Reference air permeability related to joint length	Q100 < 0,10 m³/hm
Reference air permeability related to overall area	Q100 = 0,59 m³/hm²

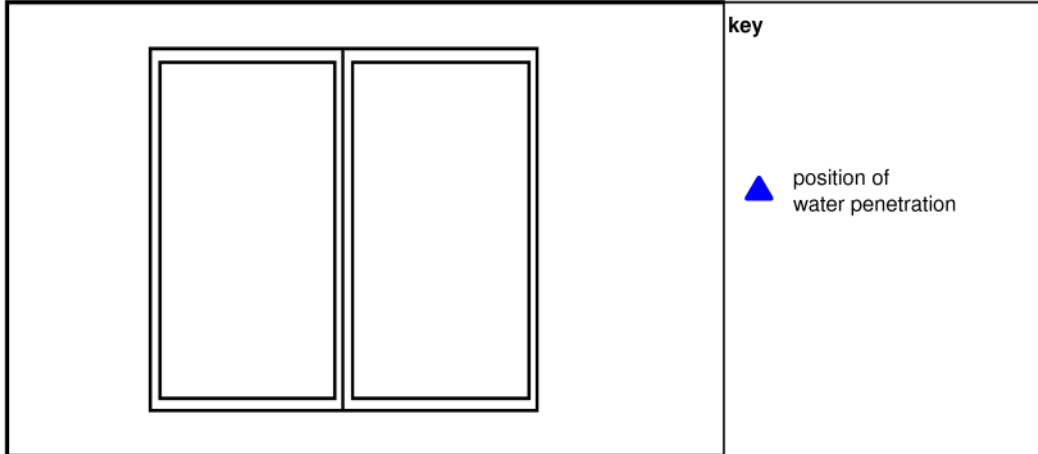
View of test specimen

Closing condition closed and locked  
Size of window frame 1400 mm x 1500 mm  
Spray method A (Spray angle 24°)  
Number of spray nozzles 4 Lower nozzle line 0  
Water amount 480 l/h Water amount 0 l/h  
0.48 m³/h 0.00 m³/h  
Initial load before positive wind pressure was applied.

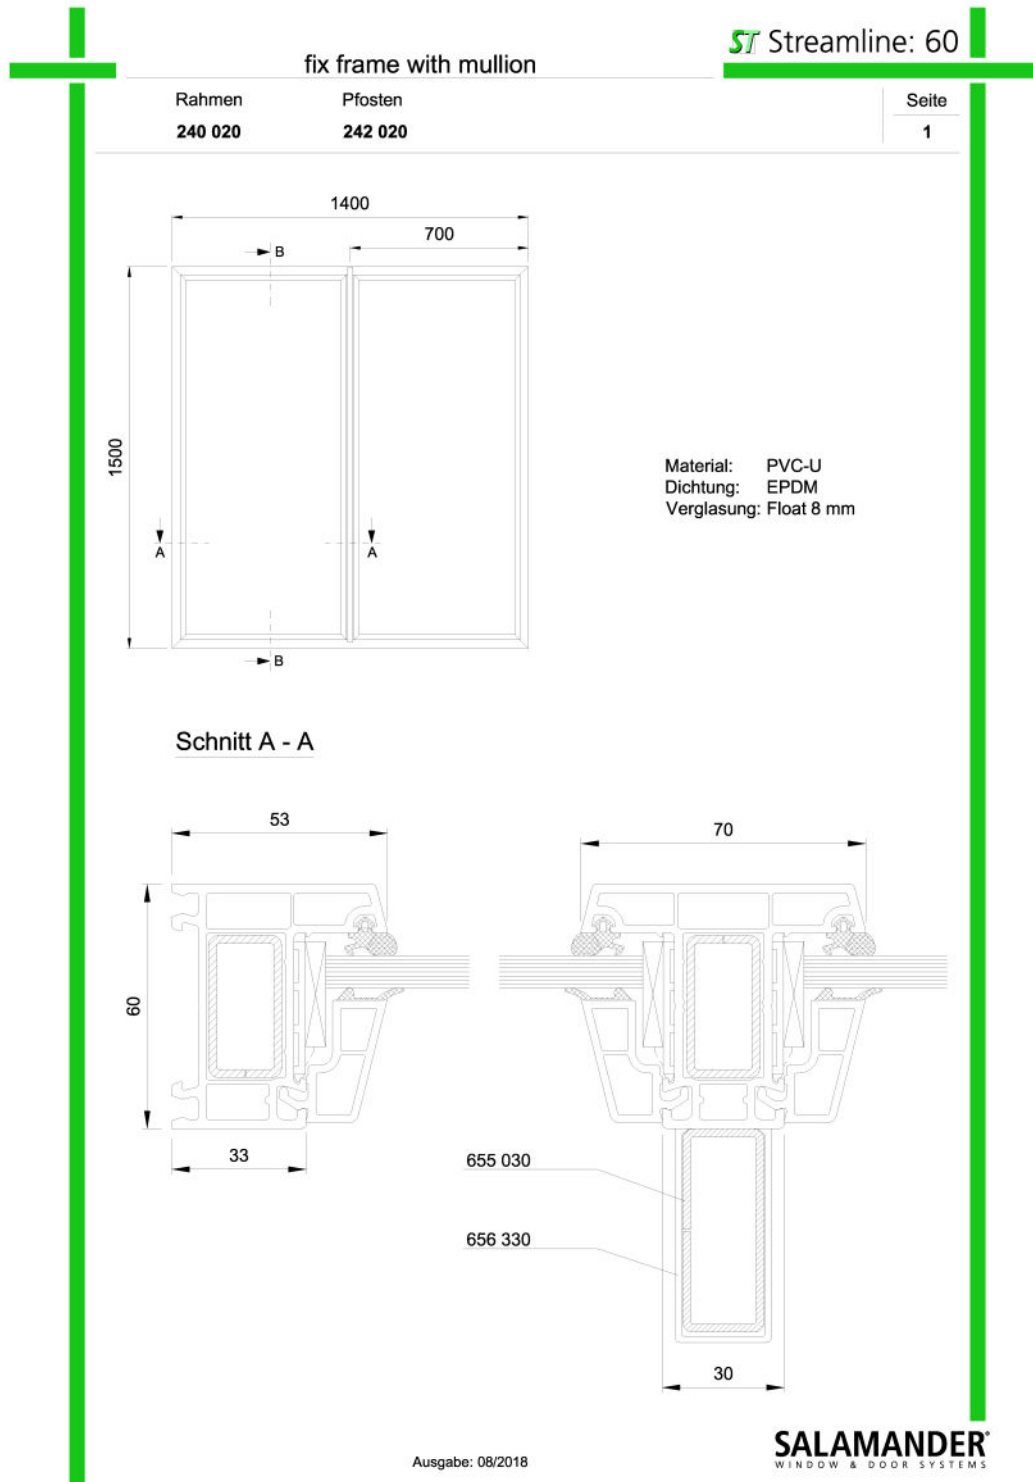
Picture 1 View and vertical section

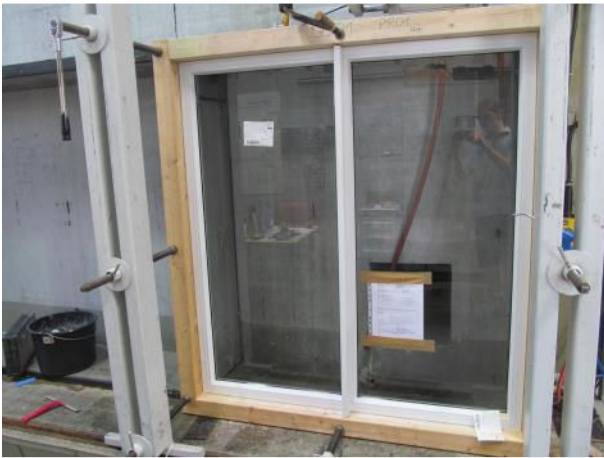
Picture 1 View of test specimen, seen from inside

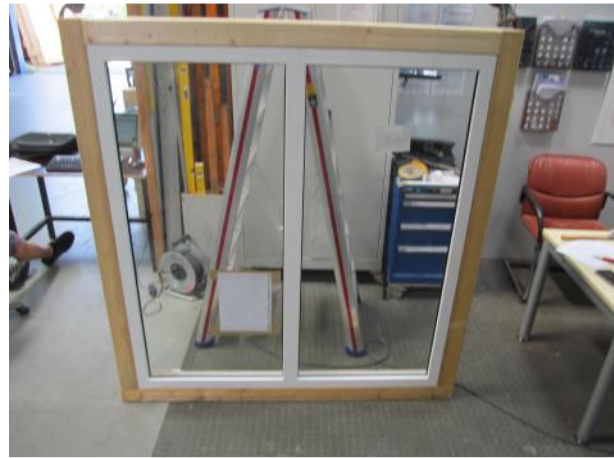
Picture 2 View of test specimen, seen from outside

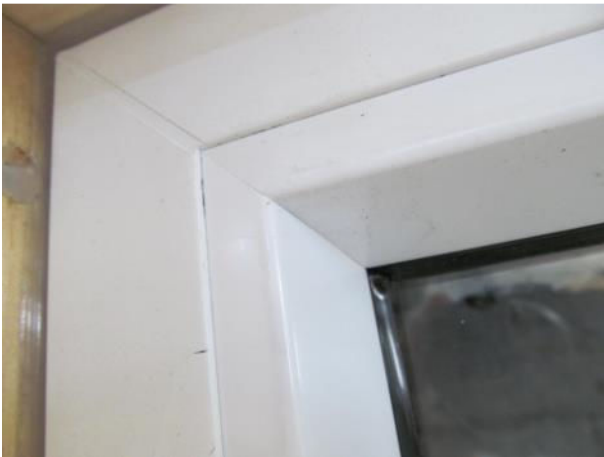
Picture 3 Internal corner design

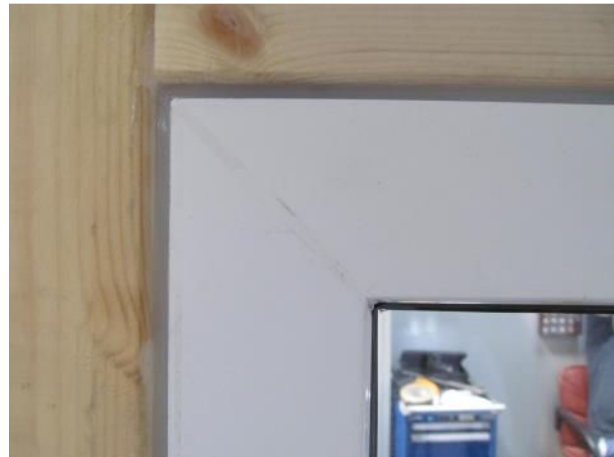
Picture 4 External corner design

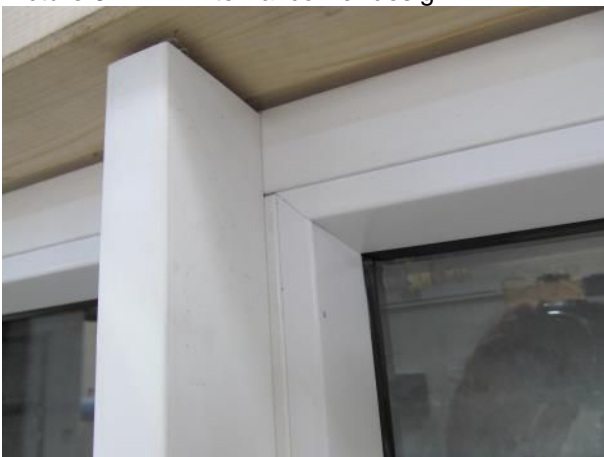
Picture 5 Central meeting joint, at top

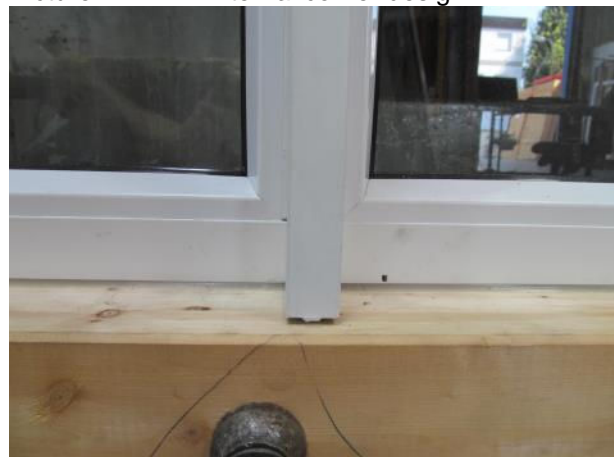
Picture 6 Central meeting joint, at bottom

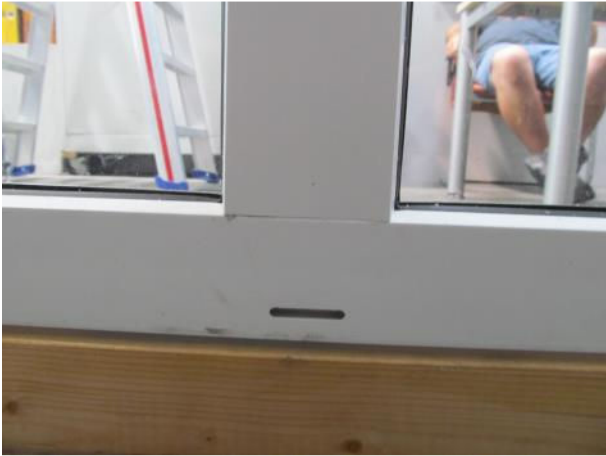
Picture 7 Drainage

<b>Druckausgleich Belüftung</b> Pressure equalisation	*Im Glasfalz: Je Feld 2 Bohrungen Ø 8 mm, nach außen: Je Feld 2 Bohrungen Ø 4 mm Inside rebate: __ drillings Ø __ mm, to outside front: __ drillings Ø __ mm
<b>Füllung</b> Infill panel	Floatglas
<b>Glasaufbau</b> Glass configuration	*
<b>Gesamtdicke</b> Total thickness	*8 mm
<b>Einbau der Füllungen</b> Installation of infill panels	2
<b>Verglasungsdichtung außen</b> External glazing gasket	
<b>Hersteller / Lieferant</b> Manufacturer / supplier	Fa. Salamander Industrie- Produkte GmbH
<b>Bezeichnung / Typ / Art.-Nr.</b> Designation / type / item no.	*Verglasungsdichtung 414 573
<b>Material</b> Material	*EPDM EPDM
<b>Eckausbildung</b> Corner design	*Umlaufend, oben mittig stumpf gestoßen und verklebt Continuous, at top centre butt-jointed and bonded
<b>Verglasungsdichtung innen</b> Internal glazing gasket	
<b>Hersteller / Lieferant</b> Manufacturer / supplier	Fa. Salamander Industrie- Produkte GmbH
