Test Report

Number	18-002246-PR02 (PB-A01-0203-en-01)
Owner (Client)	Salamander Industrie-Produkte GmbH Jakob-Sigle-Str. 58 86842 Türkheim Germany
Product	Side hung casement
Designation	Shipping name: Streamline 60
Details	Manufacturer Salamander, Industrie-Produkte GmbH – Türkheim; Material Polyvinyl Chloride unplasticized (PVC-U) white; Type of opening Turn; Opening direction DIN right, outward opening; Overall dimensions (W x H) 850 mm x 1550 mm
Special features	test sequence
Order	Testing of air permeability, watertightness, resistance to wind load, operating forces
Contents	The test report contains a total of 16 pages and annexe (9 pages).
Note	The test report shall only be published in its unabbreviated form. The “Guidance Sheet for the Use of ift Test Documents” ap- plies.

Testing of air permeability, watertightness operating forces

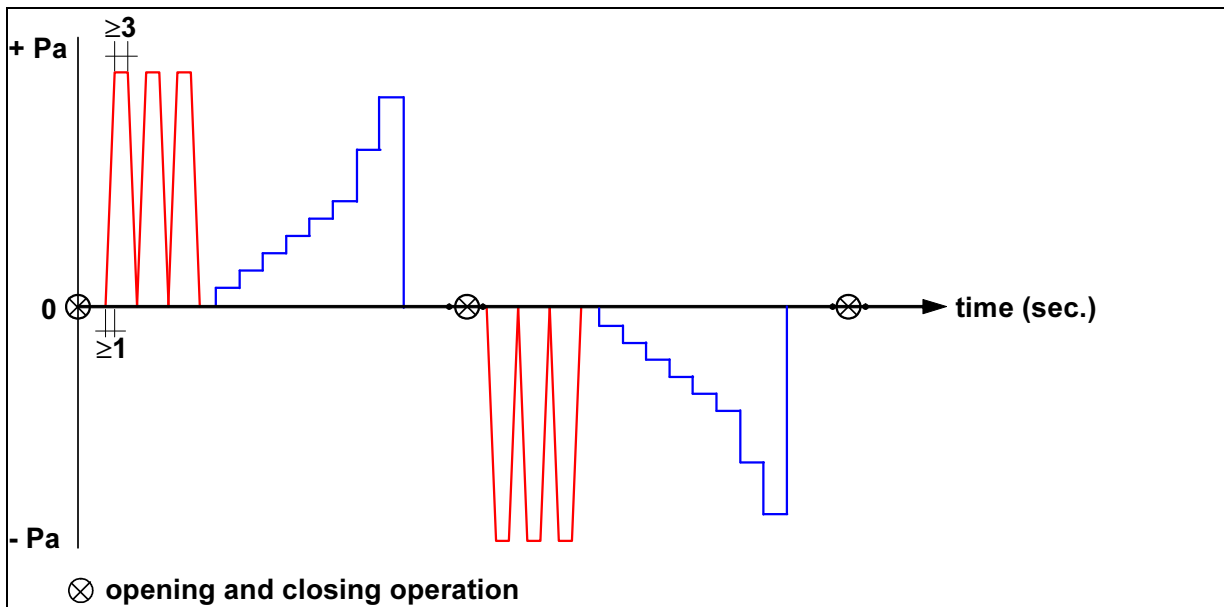
Air permeability was tested for the respective pressure steps at negative pressure and positive pressure in accordance with the following diagram. At the beginning of each measurement the test specimen was exposed to three pressure pulses.

Illustration Test sequence for air permeability

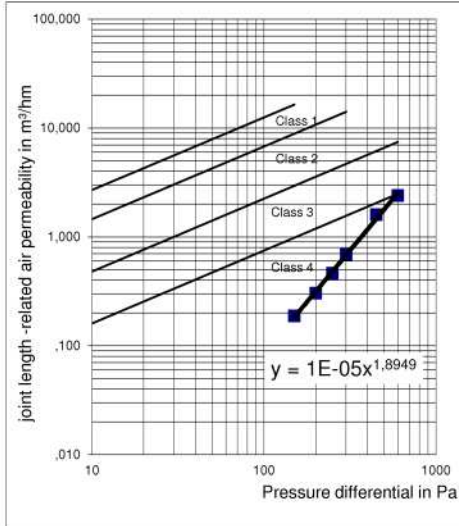
Diagram: Joint length-related air permeability (average value from positive and negative wind pressures) **Diagram:** Overall area-related air permeability (average value from positive and negative wind pressures)

Reference air permeability related to joint length	Q100 < 0,10 m³/hm
Reference air permeability related to overall area	Q100 = 0,31 m³/hm²

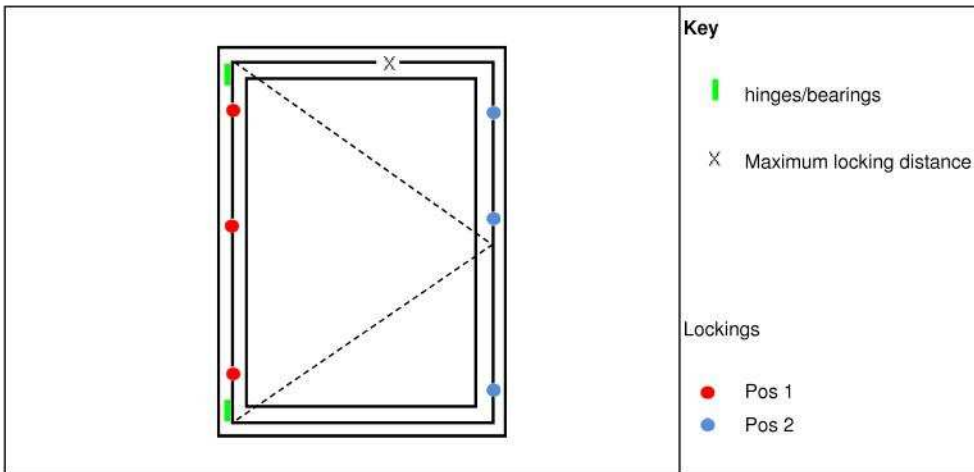
Maximum test pressure: ± 2000 Pa 3 pressure pulses of 2200 Pa

The deflection was not measured because, due to the perimeter locking and the existing locking distance at the existing specimen, the loads are directly conducted into the frame and no deformation of the frame members $> l/300$ is likely to occur at the specified wind loads.

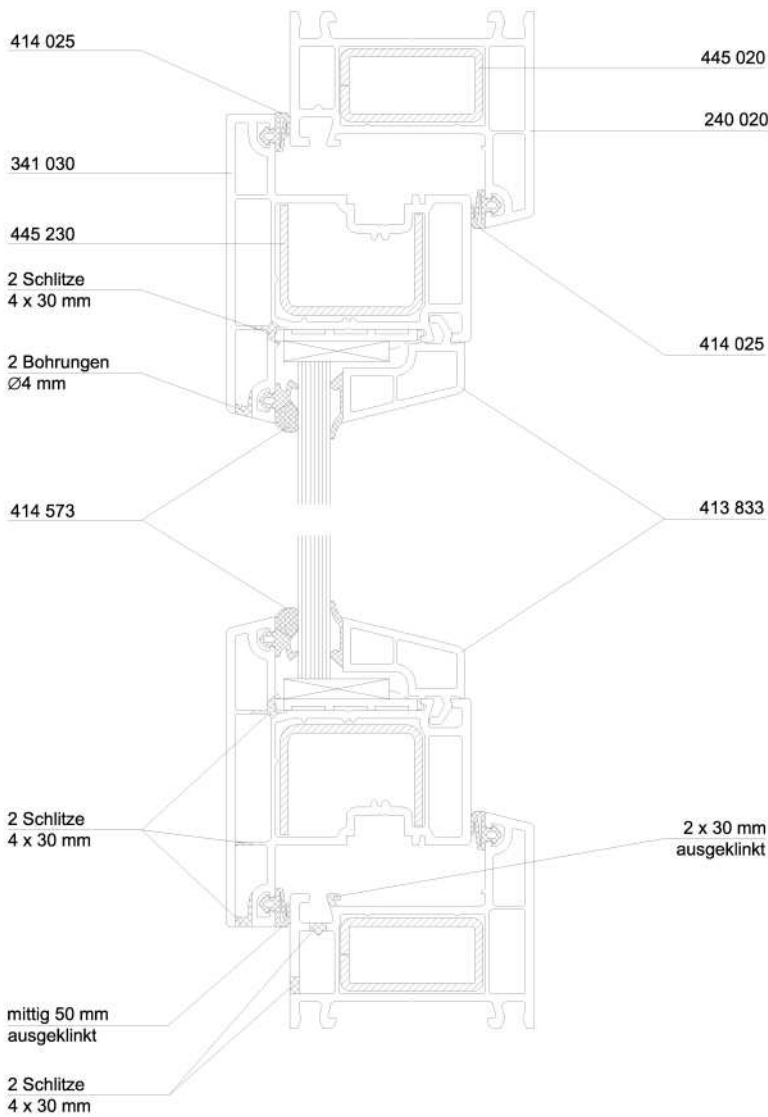
Picture 2 Vertical section

Schnitt B - B

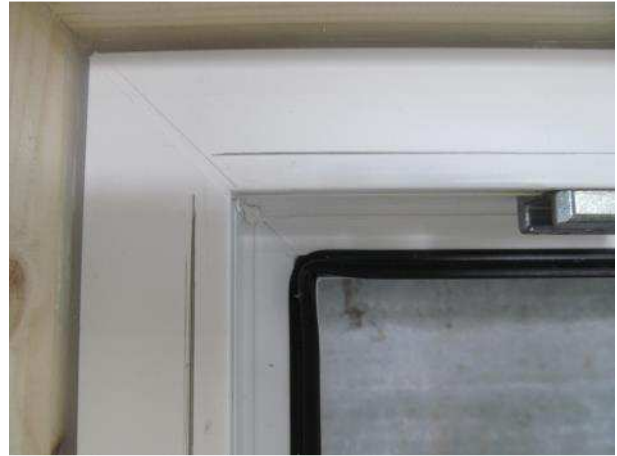
Picture 2 Rebate seal, internal

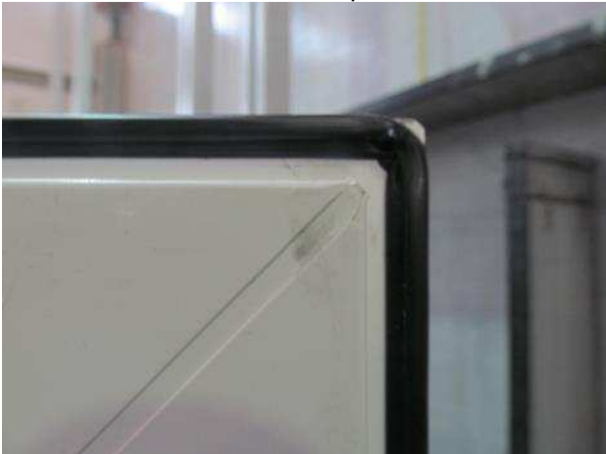
Picture 3 Rebate seal, external

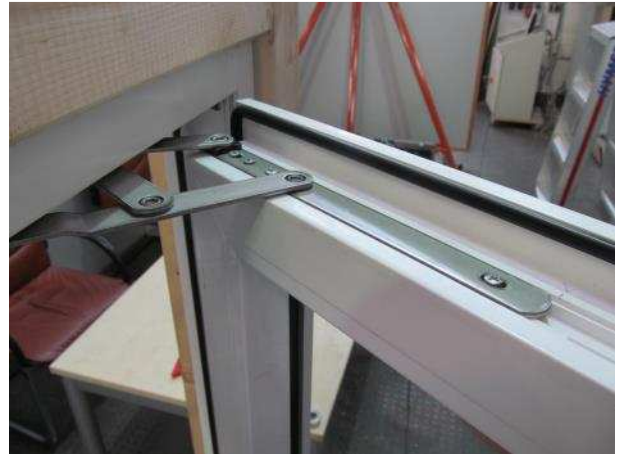
Picture 4 Tilt mechanism pivot, seen from rebate, frame

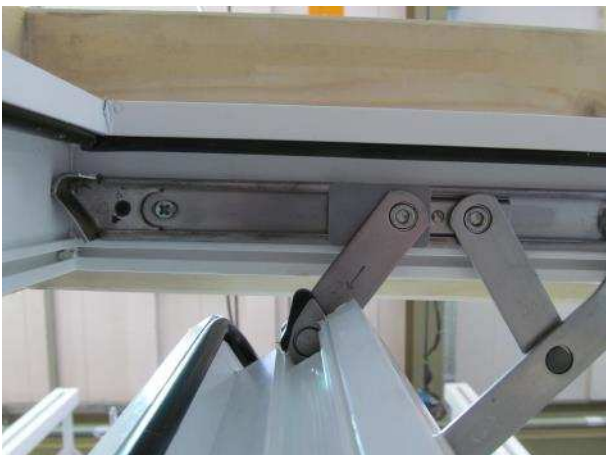
Picture 5 Tilt mechanism pivot, seen from rebate, casement

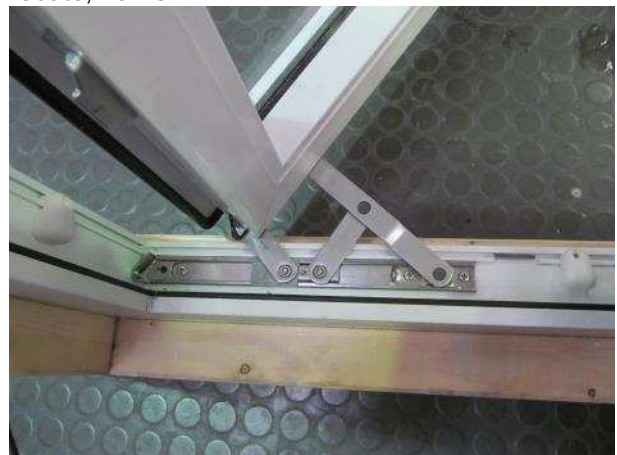
Picture 6 Corner pivot, seen from rebate

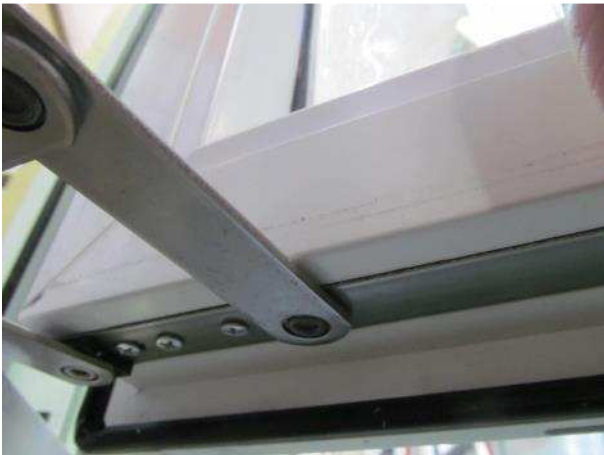
Picture 7 Corner pivot, seen from casement

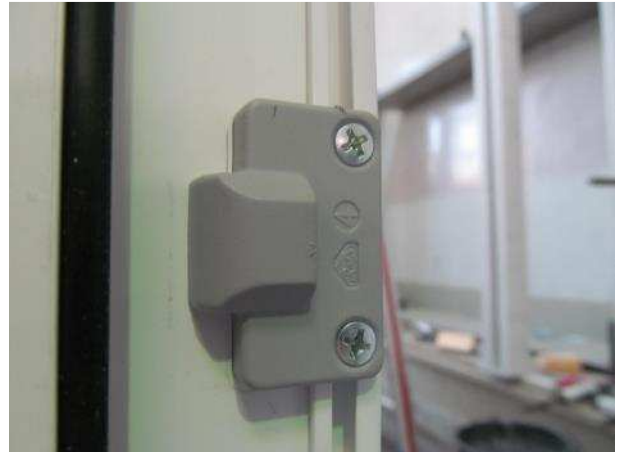
Picture 10 Locking situation frame 1

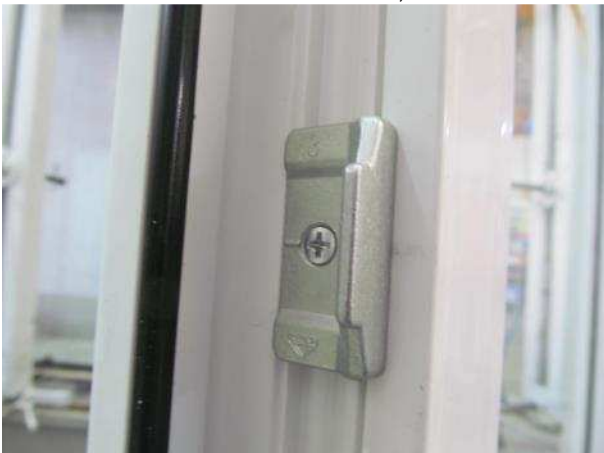
Picture 11 Locking situation casement 1

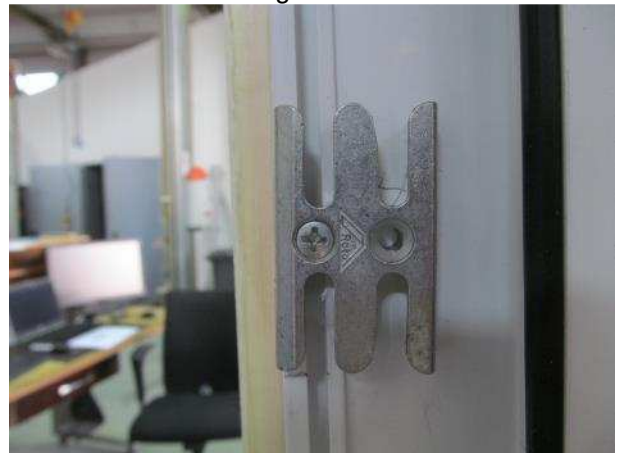
Picture 12 Locking situation frame 2

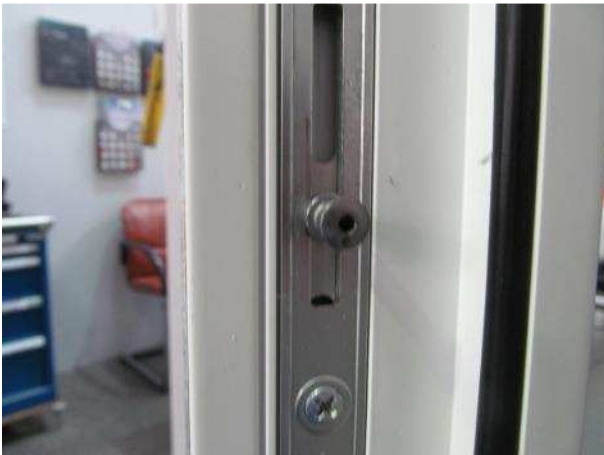
Picture 13 Locking situation casement 2

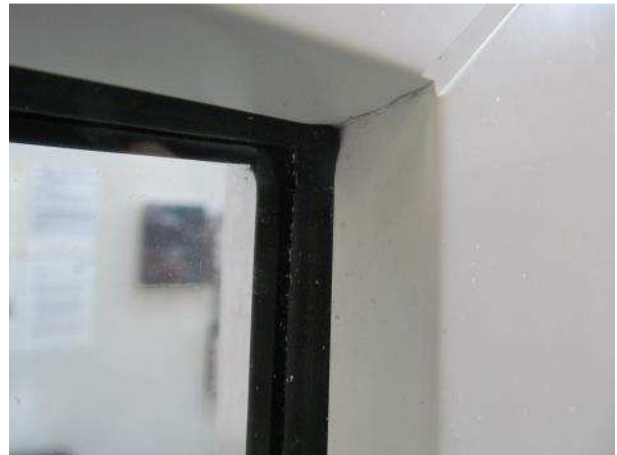
Picture 14 Fixing of the glazing external

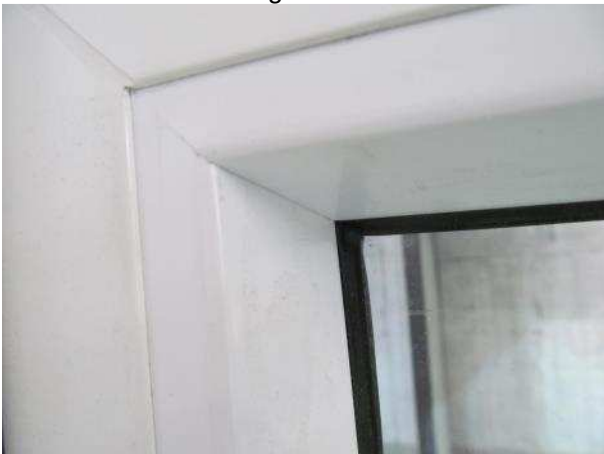
Picture 15 Fixing of the glazing internal
